Access Compliance Survey Report

ARP Sailor Bar

4253 Illinois, Fair Oaks, CA 95628

January 7, 2019

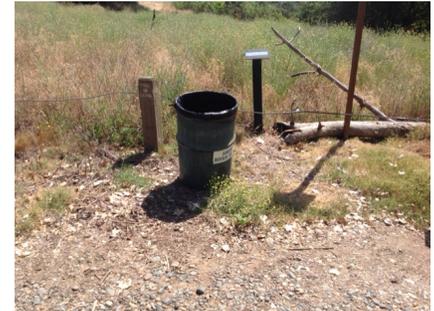
Cross Slope

- 18370 • *As-Built Description:*
Cross slope more than 1":48" (2.083%).
- *As-Built:* **Clear floor space at trash can slopes 11%.**
- *Proposed Solution:*
Modify cross slope, or relocate trash can.
- *Notes:*
This condition occurs throughout the park.

PCODE EF07REF
 ADAAG 91 4.3.7
 ADA 2010 403.3
 CBC 2007 1133B.7.1.3
 CBC 2016 11B-403.3

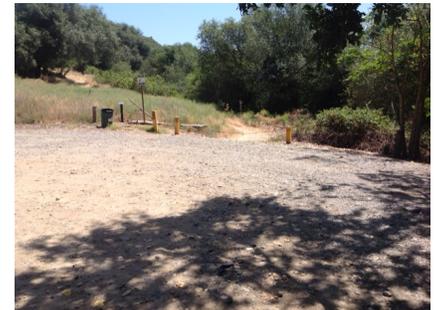
Minimum Number

- 18374 • *As-Built Description:*
At parking lot with 1-25 spaces, the number of accessible spaces is less than required by code; 1 space required
- *Proposed Solution:*
Provide required accessible parking space with sign including a minimum of one van space.
- *Notes:*
Parking not paved. Occurs at multiple trail heads.

PCODE EA01A
 ADAAG 91 4.1.2(5)
 ADA 2010 208.2
 CBC 2007 Tbl. 11B-6
 CBC 2016 11B-208.2 Tbl.
 11B-208.2

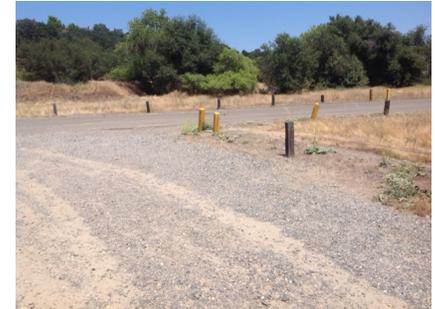
Item No. and Name	Existing Architectural Barrier and Proposed Solution	Codes / Mitigation Info	Qty	Unit	Cost	Total
18392	<ul style="list-style-type: none"> <i>As-Built Description:</i> At parking lot with 1-25 spaces, the number of accessible spaces is less than required by code; 1 space required <i>Proposed Solution:</i> Provide required accessible parking space with sign including a minimum of one van space. <i>Notes:</i> This condition occurs throughout the park. 	PCODE EA01A ADAAG 91 4.1.2(5) ADA 2010 208.2 CBC 2007 Tbl. 11B-6 CBC 2016 11B-208.2 Tbl. 11B-208.2	1	JOB	\$900	\$900

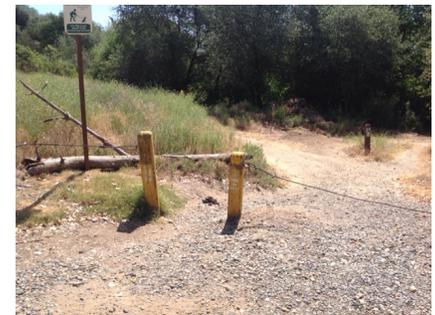
Nature Trail

18368	<ul style="list-style-type: none"> <i>As-Built Description:</i> Trail or path completely inaccessible. <i>As-Built:</i> Trail access width 30". Trails not marked. <i>Proposed Solution:</i> Create access as feasible by constructing path with gradients and surfaces that will permit at least partial use by wheelchair occupants, as detailed. (CA Only) <i>Notes:</i> This condition appears to occur at each trail head. 	PCODE NA04 CBC 2007 1132B.1 CBC 2016 11B-246.7	10	JOB	\$300	\$3,000
-------	---	--	----	-----	-------	---------

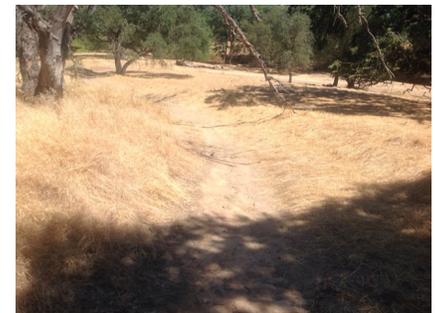
18413	<ul style="list-style-type: none"> <i>As-Built Description:</i> Trail or path completely inaccessible. <i>As-Built:</i> 25% slope, >2" level changes. Occurs throughout <i>Proposed Solution:</i> Create access as feasible by constructing path with gradients and surfaces that will permit at least partial use by wheelchair occupants, as detailed. (CA Only) <i>Notes:</i> Consider whether technically infeasible to make all trails at this park accessible. Verify which trails should be made accessible to provide access to the most important features of this park. In addition consider providing trailhead signs per CSPAG Section 42, IV. 	PCODE NA04 CBC 2007 1132B.1 CBC 2016 11B-246.7	4000	SF	\$15	\$60,000
-------	---	--	------	----	------	----------

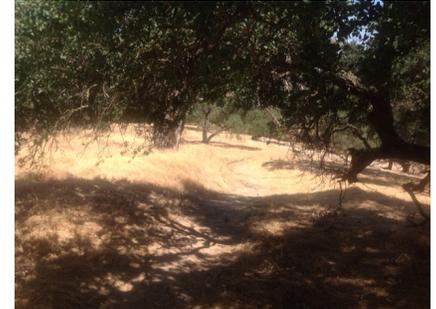
Protrusion Limits

18412	<ul style="list-style-type: none"> <i>As-Built Description:</i> Protruding objects more than 4" from wall, when bottom of object more than 27" or less than 80" above finished floor. <i>As-Built:</i> Trees 60" high. Dimensions vary. <i>Proposed Solution:</i> Trim vegetation. <i>Notes:</i> Occurs throughout park. Consider 11B-246.1 Exception 1 	<p><i>PCODE</i> EG04 <i>ADAAG 91</i> 4.4.1 <i>ADA 2010</i> 307.2 <i>CBC 2007</i> 1133B.8.6.1 <i>CBC 2016</i> 11B-307.2</p>	40	JOB	\$300	\$12,000
-------	---	--	----	-----	-------	----------

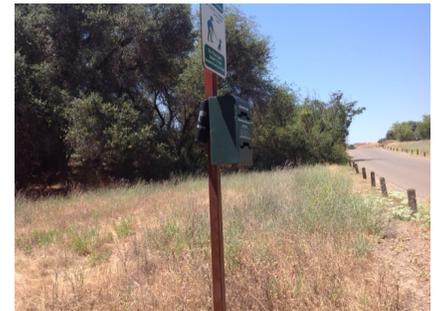
Reach Range

18393	<ul style="list-style-type: none"> <i>As-Built Description:</i> Reach height to control or access point, where side approach is available, exceeds 48" or is less than 15" in height, or exceeds 10" in depth. <i>As-Built:</i> 70" high <i>Proposed Solution:</i> Modify equipment or mounting. 	<p><i>PCODE</i> IE02 <i>ADAAG 91</i> 4.2.6 <i>ADA 2010</i> 308.3.1 <i>CBC 2007</i> 1118B.6 <i>CBC 2016</i> 11B-308.3</p>	10	JOB	\$300	\$3,000
-------	--	--	----	-----	-------	---------

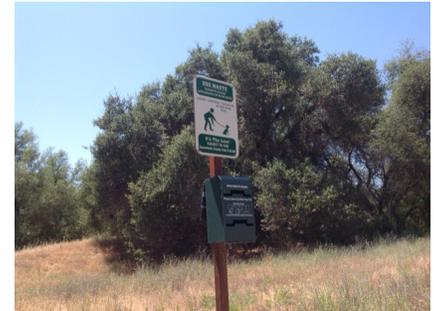
Signage

18394	<ul style="list-style-type: none"> <i>As-Built Description:</i> Sign characters not readable because they are not sized for viewing distance. <i>Proposed Solution:</i> Provide compliant signage. <i>Notes:</i> 93" above finished floor 1/2" high characters. Occurs throughout park approx. 20 	<i>PCODE SA02A</i> <i>ADAAG 91 4.30.3</i> <i>ADA 2010 703.5.5</i> <i>CBC 2007 1117B.5.4</i> <i>CBC 2016 11B-308.3</i>	10	JOB	\$270	\$2,700
-------	---	---	----	-----	-------	----------------

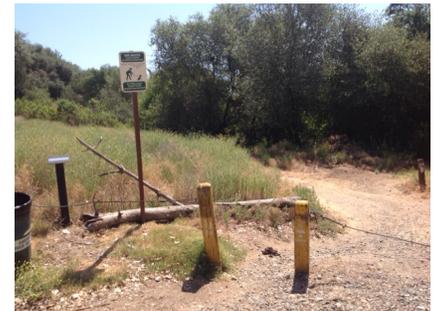
Trails

18369	<ul style="list-style-type: none"> <i>As-Built Description:</i> No sign to identify accessible trail (trail segment) at trailhead or designated access point. <i>Proposed Solution:</i> Provide sign. 	<i>PCODE NE20</i> <i>ADAAG 91 16.2.10</i> <i>ADA 2010 216.3</i> <i>CBC 2007 1132B.1</i> <i>CBC 2016 11B-216.3</i>	12	SF		
-------	---	---	----	----	--	--

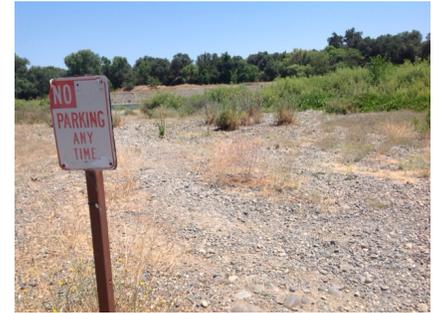
Beach Access

Beach access route at existing beach or developed site does not extend to high tide level, mean river bed level, or normal recreation water level.

No accessible route to river. may be closest place to river for people who cannot travel long distances.

PCODE NG04
 ADAAG 91 16.4.1
 CBC 2007 1132B.1
 CBC 2016 11B-246.3

Extend as required.

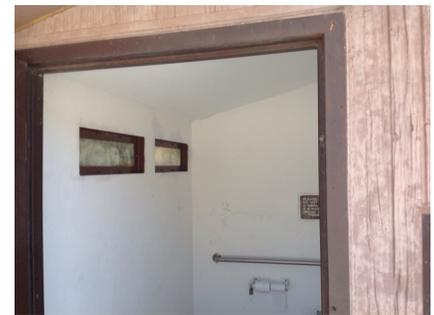
Door Clearance

Door on accessible route has less than 32" clear and 80" (78" min. to closer if provided) opening width when 90° open.

• *As-Built:* **79.80" clear**

PCODE ID01
 ADAAG 91 4.13.5
 ADA 2010 404.2.3
 CBC 2007 1133B.1.1.1.1
 CBC 2016 11B-404.2.3

Provide new, larger door and frame with new accessible hardware.

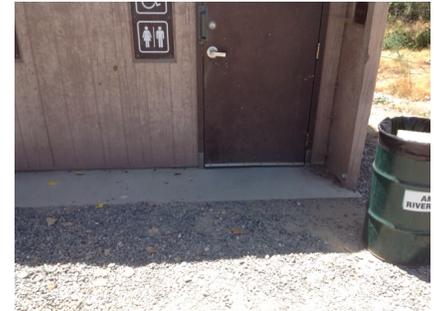
Door Swing

18379	<ul style="list-style-type: none"> <i>As-Built Description:</i> Front approach: At pull side, door does not have clear and level maneuvering space measuring door width plus 18" x 60". (24" x 60" at exterior doors). <i>As-Built:</i> 6%, not stable firm. <i>Proposed Solution:</i> Extend pavement to >60" measured perpendicular to door. 	PCODE ID23 ADAAG 91 Fig. 25(a) ADA 2010 404.2.4 CBC 2007 11B-26A(a) CBC 2016 11B-404.2.4	2	JOB	\$1,500	\$3,000
-------	---	--	---	-----	---------	---------

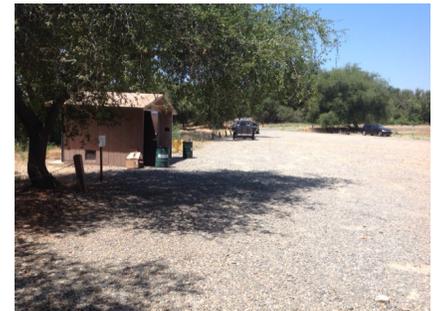
Minimum Number

18375	<ul style="list-style-type: none"> <i>As-Built Description:</i> At parking lot with 26-50 spaces, the number of accessible spaces is less than required by code; 2 spaces required. <i>Proposed Solution:</i> Provide required accessible parking spaces with signs including a minimum of one van space. <i>Notes:</i> No accessible parking at restrooms. Not paved. Unable to verify number of spaces. 	PCODE EA01B ADAAG 91 4.1.2(5)* ADA 2010 208.2 CBC 2007 Tbl. 11B-6 CBC 2016 11B-208.2 Tbl. 11B-208.2	2	JOB	\$900	\$1,800
-------	---	---	---	-----	-------	---------

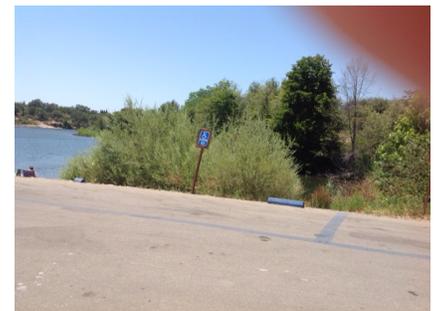
18383	<ul style="list-style-type: none"> <i>As-Built Description:</i> At parking lot with 1-25 spaces, the number of accessible spaces is less than required by code; 1 space required <i>Proposed Solution:</i> Provide required accessible parking space with sign including a minimum of one van space. <i>Notes:</i> No accessible parking/multiple violation. 	PCODE EA01A ADAAG 91 4.1.2(5) ADA 2010 208.2 CBC 2007 Tbl. 11B-6 CBC 2016 11B-208.2 Tbl. 11B-208.2	1	JOB	\$900	\$900
-------	--	--	---	-----	-------	-------

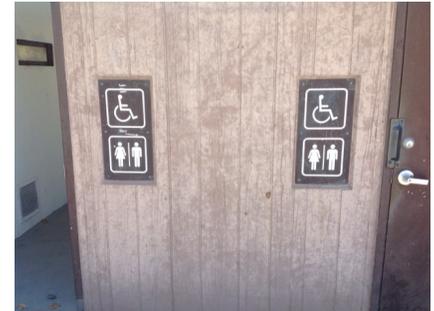
Signage

18377	<ul style="list-style-type: none"> <i>As-Built Description:</i> Entrance to toilet or bathing facility not identified with ADAAG compliant signage. <i>Proposed Solution:</i> Provide ADA compliant sign mounted at 48" min. above to baseline of the lowest Braille cells and 60" max. to baseline of the highest line of raised characters on nearest adjacent wall, on latch side of a single door (located not to cause a Braille reader to stand within the door swing). 	<p>PCODE SA11A ADAAG 91 4.1.3(16)(a) ADA 2010 216.8 CBC 2016 11B-216.8</p>	2	JOB	\$270	\$540
-------	---	---	---	-----	-------	-------

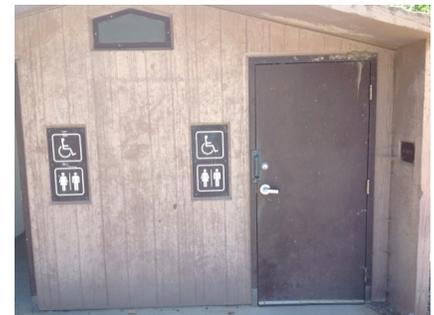
18378	<ul style="list-style-type: none"> <i>As-Built Description:</i> Required in CA only: identification symbol centered 58" to 60" high on sanitary facility door that contrasts with the door not provided (women: 12" ø circle, men: 12" triangle, unisex: combined symbol). <i>Proposed Solution:</i> Provide properly mounted sanitary facility symbol when altering area. If wheelchair accessible, include International Symbol of Accessibility on sign. 	<p>PCODE SA15 CBC 2007 1115B.6 CBC 2016 11B-703.7.2.6</p>	2	JOB	\$270	\$540
-------	---	---	---	-----	-------	-------

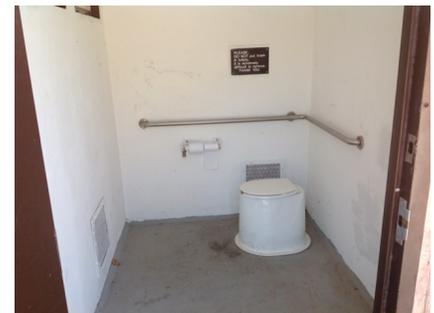
Water Closet

18376	<ul style="list-style-type: none"> <i>As-Built Description:</i> CA only: In single-accommodation restroom less than 48" in front of water closet provided. <i>As-Built:</i> 37" in front <i>Proposed Solution:</i> Remodel restroom to provide at least 48" in front of water closet. <i>Notes:</i> It appears there is room to rotate the WC 90 degrees to create compliance. The grab bars and dispenser will also require relocation. There are no lavatories in these restrooms. The restrooms are 64" x 87". 	<p>PCODE WB03A CBC 2007 1115B.3.2.1 CBC 2016 11B-604.3.1</p>	2	JOB	\$15,000	\$30,000
-------	---	--	---	-----	----------	----------

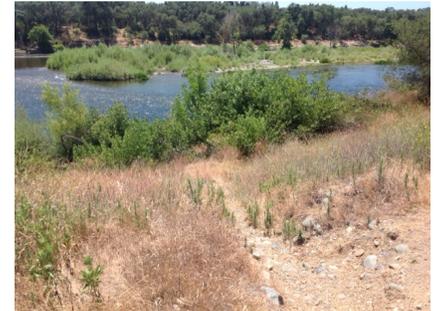
Beach Access

18388 • *As-Built Description:*
 Beach access route at existing beach or developed site does not extend to high tide level, mean river bed level, or normal recreation water level.

• **Notes:**
No accessible route to the river. The activities at this park appear to center around the river. Consider installing an accessible route or trail to the river. Consider whether it is technically feasible to make all trails at this park accessible. Verify which trails other than river access trails should be made accessible to provide access to the most important features of this park. In addition, the trails do not appear to comply with 11B-246.8. Document basis for exceptions per Federal F201.4.1

PCODE NG04
 ADAAG 91 16.4.1
 CBC 2007 1132B.1
 CBC 2016 11B-246.3

• *Proposed Solution:*
 Extend as required.

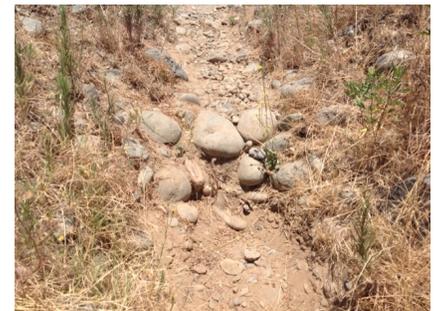
Nature Trail

18387 • *As-Built Description:*
 Trail or path completely inaccessible.

• *As-Built:* **10" level change. Cross slopes to 20%. Running slopes to 30 %.**

PCODE NA04
 CBC 2007 1132B.1
 CBC 2016 11B-246.7

• *Proposed Solution:*
 Create access as feasible by constructing path with gradients and surfaces that will permit at least partial use by wheelchair occupants, as detailed. (CA Only)

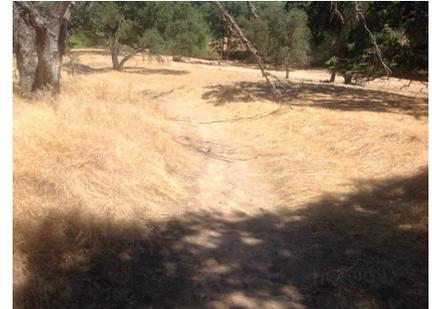
Item No. and Name	Existing Architectural Barrier and Proposed Solution	Codes / Mitigation Info	Qty	Unit	Cost	Total
10323	<ul style="list-style-type: none"> <i>As-Built Description:</i> Nature trail or other natural education facility not accessible to blind persons. <i>Proposed Solution:</i> Provide rope guidelines, raised-numeral signs and symbols and related guide and assistance devices as feasible to create access. 	<p>PCODE NA06</p> <p>CBC 2007 1132B.1</p> <p>CBC 2016 11B-246.8</p>	1	JOB		
						<p>Mitigated:</p> <p><input type="radio"/> YES <input checked="" type="radio"/> NO</p>

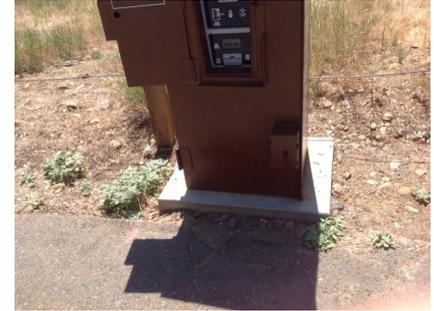
Changes in Level

- 18397
- As-Built Description:*
Walk: Pavement dislocation creates abrupt change in level exceeding 1/2" in accessible route.
 - As-Built:* **1" high**
 - Proposed Solution:*
Remove, replace or repair area of pavement sufficient to correct abrupt change in level.
 - Notes:*
Occurs at teller clear floor space.

PCODE EF03
 ADAAG 91 4.3.8
 ADA 2010 403.4
 CBC 2007 1133B.7.4
 CBC 2016 11B-403.4

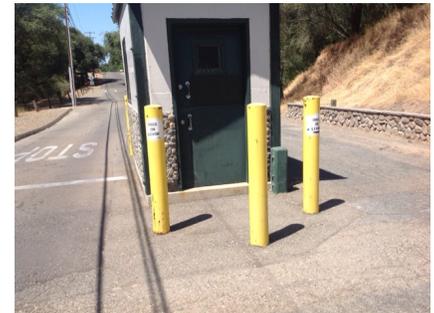
Curb Ramp

- 18401
- As-Built Description:*
No curb ramp available where an accessible route crosses a curb.
 - Proposed Solution:*
Provide new curb ramp.
 - Notes:*
Pay station employee entrance not on accessible route due to curb.

PCODE EH01
 ADAAG 91 4.7.1
 ADA 2010 303.4
 CBC 2007 1127B.5.1
 CBC 2016 11B-402.2

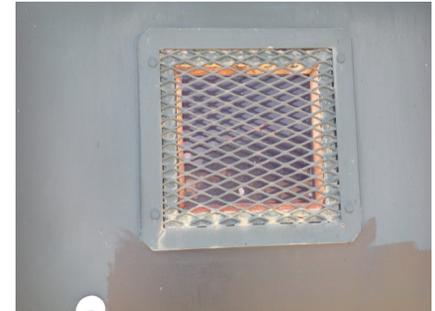
Door

18403	<ul style="list-style-type: none"> • <i>As-Built Description:</i> Vision Light at door that permits viewing, does not have bottom of at least one glazed panel located 43 inches maximum above the finish floor. (Exception: More than 66" above finished floor.) • <i>As-Built:</i> 60" above finished floor • <i>Proposed Solution:</i> Provide new door with vision panel at 43" max. 	<p>PCODE ID06C</p> <p>ADA 2010 404.2.11</p> <p>CBC 2016 11B-404.2.11</p>	1	JOB	\$7,500	\$7,500
-------	--	--	---	-----	---------	----------------

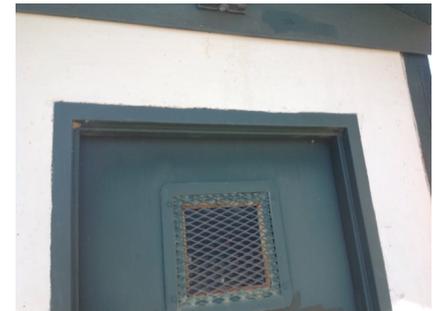
Door Clearance

18402	<ul style="list-style-type: none"> • <i>As-Built Description:</i> Door on accessible route has less than 32" clear and 80" (78" min. to closer if provided) opening width when 90° open. • <i>As-Built:</i> 79.75" clear • <i>Proposed Solution:</i> Provide new, larger door and frame with new accessible hardware. 	<p>PCODE ID01</p> <p>ADAAG 91 4.13.5</p> <p>ADA 2010 404.2.3</p> <p>CBC 2007 1133B.1.1.1.1</p> <p>CBC 2016 11B-404.2.3</p>	1	JOB	\$7,800	\$7,800
-------	---	--	---	-----	---------	----------------

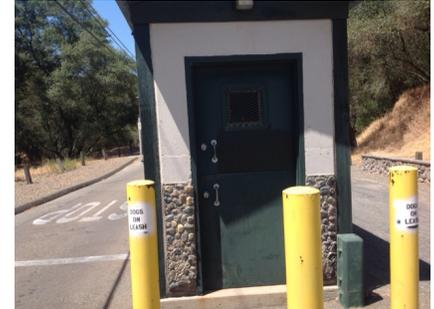
Door Swing

18404 • *As-Built Description:*
 Front approach: At pull side, door does not have clear and level maneuvering space measuring door width plus 18" x 60". (24" x 60" at exterior doors).
 • *As-Built:* **Approx. 12" on strike side**
 • *Proposed Solution:*
 Change door swing, Relocate bollard.
 • **Notes:**
Measurement based on exterior dimensions and typical.

PCODE ID23
 ADAAG 91 Fig. 25(a)
 ADA 2010 404.2.4
 CBC 2007 11B-26A(a)
 CBC 2016 11B-404.2.4

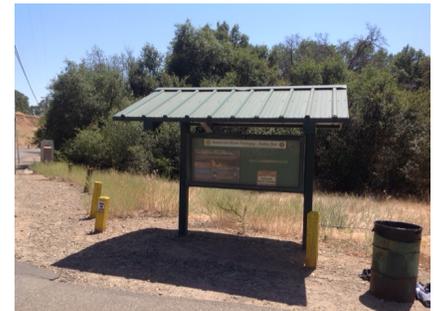
Protrusion Limits

18400 • *As-Built Description:*
 Protruding objects more than 4" from wall, when bottom of object more than 27" or less than 80" above finished floor.
 • *As-Built:* **34" to bottom of sign. 68" to kiosk head room**
 • *Proposed Solution:*
 Modify information kiosk.

PCODE EG04
 ADAAG 91 4.4.1
 ADA 2010 307.2
 CBC 2007 1133B.8.6.1
 CBC 2016 11B-307.2

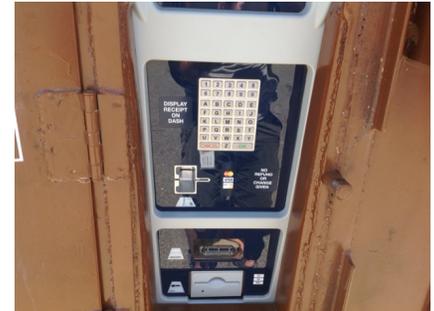
Self Service Machine

18398	<ul style="list-style-type: none"> <i>As-Built Description:</i> Self-service machine with touch screen controls not operable by people with visual and hearing impairments. <i>As-Built:</i> Vertical screen 57" above finished floor. <i>Proposed Solution:</i> Modify equipment to provide methods that enable a visually and hearing impaired person the same opportunity for the same degree of privacy to access the machine. <i>Notes:</i> Multiple barriers. Numeric keys not in correct pattern. No Braille or tactile. not speech enabled. 	<p>PCODE IL03NT</p> <p>CBC 2016 11B-220.2; 11B-707</p>	1	JOB	\$6,000	\$6,000
-------	---	--	---	-----	---------	---------

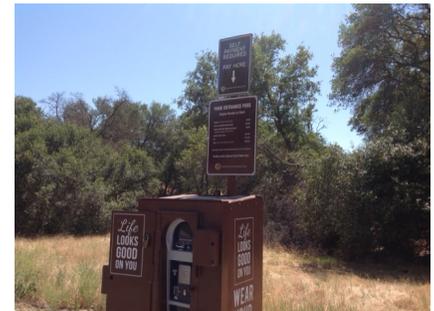
Signage

18405	<ul style="list-style-type: none"> <i>As-Built Description:</i> Sign characters not readable because they are not sized for viewing distance. <i>As-Built:</i> Characters 77" - 110" above finished floor. 3/8" - 1" high characters. <i>Proposed Solution:</i> Provide compliant signage. 	<p>PCODE SA02A</p> <p>ADAAG 91 4.30.3</p> <p>ADA 2010 703.5.5</p> <p>CBC 2007 1117B.5.4</p> <p>CBC 2016 11B-703.4.2</p>	1	JOB	\$270	\$270
-------	--	---	---	-----	-------	-------

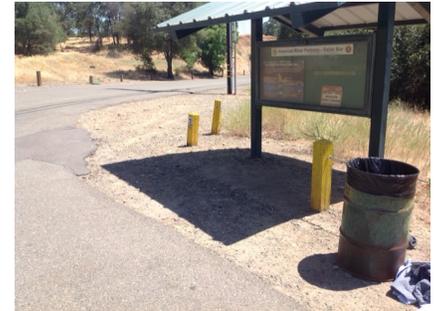
Walkway Surface

18399	<ul style="list-style-type: none"> <i>As-Built Description:</i> The pedestrian access route is not provided <i>Proposed Solution:</i> Pave or provide walk to Kiosk Area. 	<p><i>PCODE</i> PR18B</p> <p><i>ADAAG 91</i> 4.5.2</p> <p><i>PROW</i> R302.7.1</p> <p><i>CBC 2007</i> 1133B.7.1</p> <p><i>CBC 2016</i> 11B-403.3</p>	20	SF	\$120	\$2,400
-------	---	---	----	----	-------	----------------

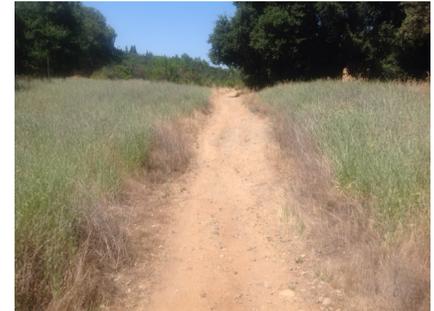
Beach Access

18408 • *As-Built Description:*
Beach access route at existing beach or developed site does not extend to high tide level, mean river bed level, or normal recreation water level.

PCODE NG04
ADAAG 91 16.4.1
CBC 2007 1132B.1
CBC 2016 11B-246.3

• *As-Built:* **Excess of 19%. caused by trail deterioration**

Extend as required.

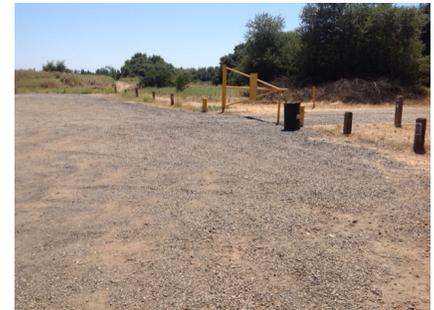
PCODE EA01A
ADAAG 91 4.1.2(5)
ADA 2010 208.2
CBC 2007 Tbl. 11B-6
CBC 2016 11B-208.2 Tbl. 11B-208.2

Provide required accessible parking space with sign including a minimum of one van space.

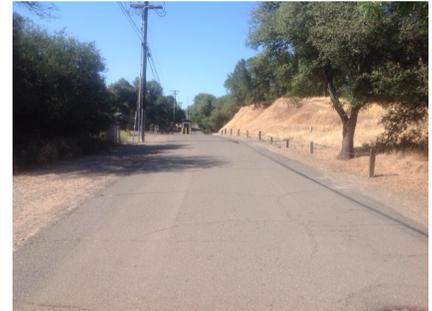
- 18415 • *As-Built Description:*
Refer to notes for observation and recommendation.
- *As-Built:* **Slopes to 8.6% were measured on the drive from Illinois to the boat launch with slopes to 10.6% measured on the**
- *Proposed Solution:*
Route from PROW coincides with vehicular way.

CBC 2016 11B-403.3

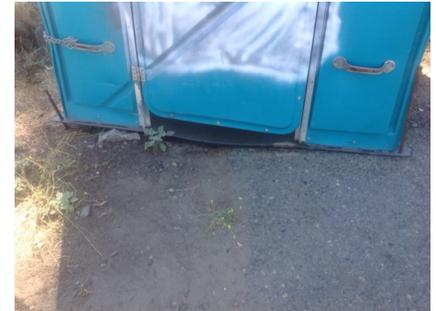
Door Threshold

18417	<ul style="list-style-type: none"> • <i>As-Built Description:</i> Door inaccessible due to threshold or step at door exceeding 1/2". • <i>As-Built:</i> 1.5" at portable restroom • <i>Proposed Solution:</i> Modify threshold to be no more than 1/2" by removing existing paving at door and providing landing with edge ramping (slope 1:20 max). 	<p>PCODE ID02A ADAAG 91 4.13.8 ADA 2010 404.2.5 CBC 2007 1133B.2.4.1 CBC 2016 11B-404.2.5</p>	1	JOB	\$1,200	\$1,200
-------	--	---	---	-----	---------	----------------

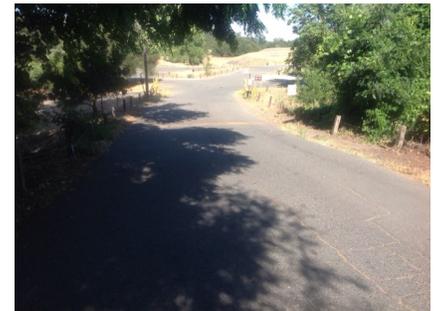
18423	<ul style="list-style-type: none"> • <i>As-Built Description:</i> Refer to notes for observation and recommendation. • <i>As-Built:</i> 13% on Olive Ave. The surveyor does not know whether the slopes on Olive are on park property. The speed • <i>Proposed Solution:</i> It appears the route from the PROW into the park coincides with a vehicular way. 	<p>PCODE GN01 CBC 2016 11B-403.3</p>				
-------	---	--	--	--	--	--

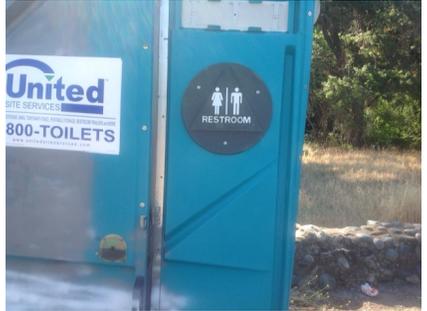
Item No. and Name	Existing Architectural Barrier and Proposed Solution	Codes / Mitigation Info	Qty	Unit	Cost	Total
Signage						
18419	<ul style="list-style-type: none"> As-Built Description: Required in CA only: identification symbol centered 58" to 60" high on sanitary facility door that contrasts with the door not provided (women: 12" ø circle, men: 12" triangle, unisex: combined symbol). Proposed Solution: Provide properly mounted sanitary facility symbol when altering area. If wheelchair accessible, include International Symbol of Accessibility on sign. Notes: No contrast. 	PCODE SA15 CBC 2007 1115B.6 CBC 2016 11B-703.7.2.6	1	JOB	\$270	\$270

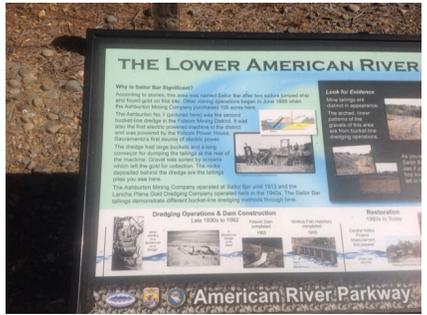
Mitigated: <input type="radio"/> YES <input checked="" type="radio"/> NO			
18420	<ul style="list-style-type: none"> As-Built Description: Sign characters not readable because they are not sized for viewing distance. As-Built: 5/16" high Characters Proposed Solution: Provide compliant signage. 	PCODE SA02A ADAAG 91 4.30.3 ADA 2010 703.5.5 CBC 2007 1117B.5.4 CBC 2016 11B-703.7.2.6	5	JOB	\$270	\$1,350

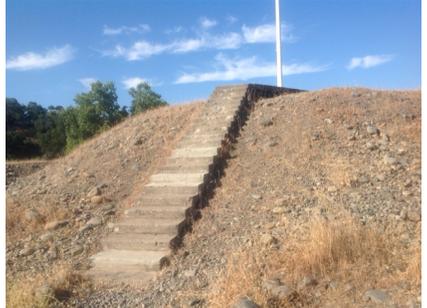
Mitigated: <input type="radio"/> YES <input checked="" type="radio"/> NO			
Stairways						
18424	<ul style="list-style-type: none"> As-Built Description: Exterior stair substantially out of compliance. As-Built: Stairs to flagpole cross slope 4%. No level landing. No handrails. No guards. Proposed Solution: Provide complete new stair, 4 ft. wide with landing and handrails. Notes: These are stairs to a memorial. Check historical protection. 	PCODE EC09 ADAAG 91 4.9 ADA 2010 504 CBC 2007 1133B.4 CBC 2016 11B-504	300	IN	\$270	\$81,000

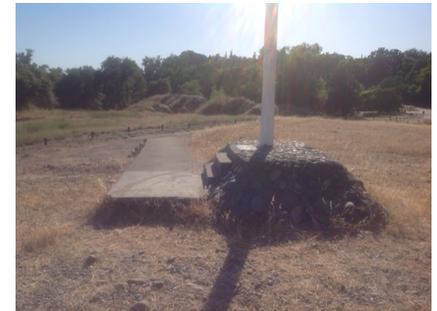
Item No. and Name	Existing Architectural Barrier and Proposed Solution	Codes / Mitigation Info	Qty	Unit	Cost	Total
18427	<ul style="list-style-type: none"> • <i>As-Built Description:</i> Exterior stair substantially out of compliance. • <i>As-Built:</i> Treads 7" deep. Risers 4" - 6.5" high. Top landing 46" deep. • <i>Proposed Solution:</i> Provide complete new stair, 4 ft. wide with landing and handrails. • <i>Notes:</i> Landing obstructed by flag pole. These are stairs to a memorial. Check historical protection. 	PCODE EC09 ADAAG 91 4.9 ADA 2010 504 CBC 2007 1133B.4 CBC 2016 11B-504	30	IN	\$270	\$8,100

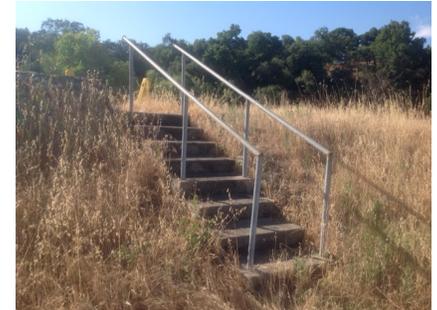
18429	<ul style="list-style-type: none"> • <i>As-Built Description:</i> Exterior stair substantially out of compliance. • <i>As-Built:</i> Stairs 30" wide. No extensions. No level landings • <i>Proposed Solution:</i> Provide complete new stair, 4 ft. wide with landing and handrails. • <i>Notes:</i> Appear to be employee only. 	PCODE EC09 ADAAG 91 4.9 ADA 2010 504 CBC 2007 1133B.4 CBC 2016 11B-504	150	IN	\$270	\$40,500
-------	---	--	-----	----	-------	-----------------

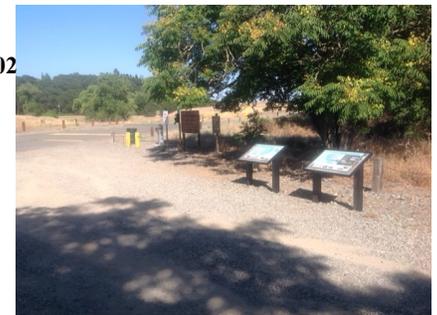
Trails

18421	<ul style="list-style-type: none"> • <i>As-Built Description:</i> Trail surface is not firm or stable. • <i>As-Built:</i> Gravel appears loose not stable firm. • <i>Proposed Solution:</i> Recondition surface. • <i>Notes:</i> Occurs at informational signs and self-pay kiosk. 	PCODE NE01 ADAAG 91 16.2.1 ADA 2010 302.10000000000002 CBC 2007 1132B.1 CBC 2016 11B-302.1	100	SF	\$15	\$1,500
-------	--	--	-----	----	------	----------------

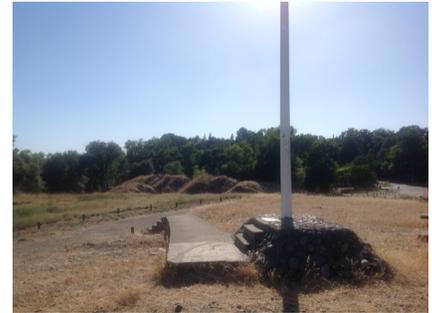
Walk

18425	<ul style="list-style-type: none"> • <i>As-Built Description:</i> Walk more than 36" but less than 48" wide (required in CA only). • <i>As-Built:</i> 37" wide • <i>Proposed Solution:</i> Enlarge width of walk to 48". 	<p><i>PCODE</i> EF08</p> <p><i>CBC 2007</i> 1133B.7.1</p> <p><i>CBC 2016</i> 11B-403.5.1.3</p>	40	SF	\$135	\$5,400
-------	--	--	----	----	-------	----------------
